Manhole Inspection Summary

Manhole # S55C__022MH

Insp Date: **6/23/08 10:09 AM**

Location Address: **rear 3637 e fayette st**

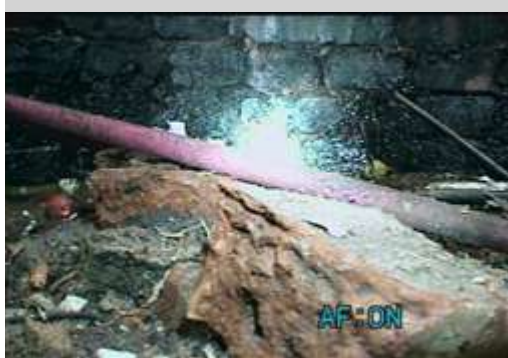
Defect 4

Condition: ☐ Sound ☐ Cracked ☐ Root Intrusion ☐ Deteriorated ☐ Leaks ☒ **Debris**

channel debris

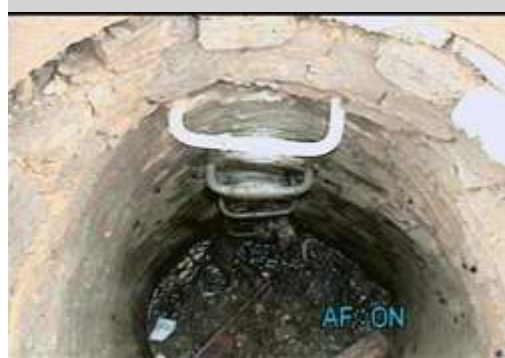
Defect 3

Steps Count: **4** Missing: **0** ☒ **Corroded**

steps

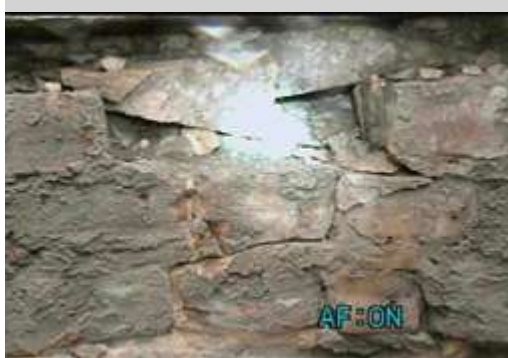
Defect 2

Condition: ☐ Sound ☒ **Cracked** ☐ Root Intrusion ☒ **Loose Brick** ☐ Deteriorated

corbel

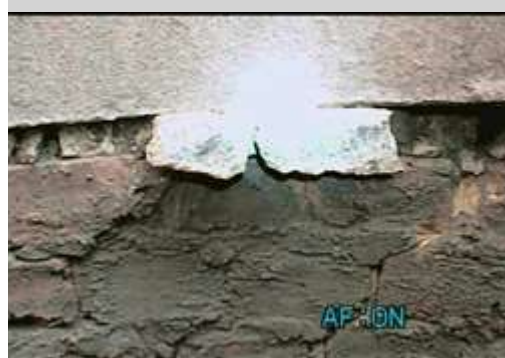
Defect 1

Condition: ☐ Sound ☐ Cracked ☐ Root Intrusion ☒ **Loose Brick** ☒ **Deteriorated**

frame adj

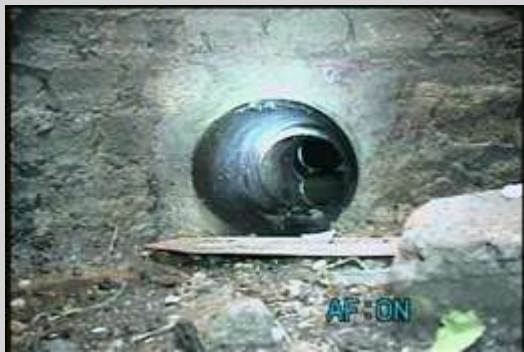
12 O'Clock Outflow

8 in. Circular Gravity Sewer
Pipe Out @ 12 O'Clock
